A. Güemes*, A. Fernandez-Lopez, P. Fernandez, A. Lozano

Detección de daño en laminados mediante sensores de fibra óptica

Damage detection in Composite laminates by Fiber optic sensors

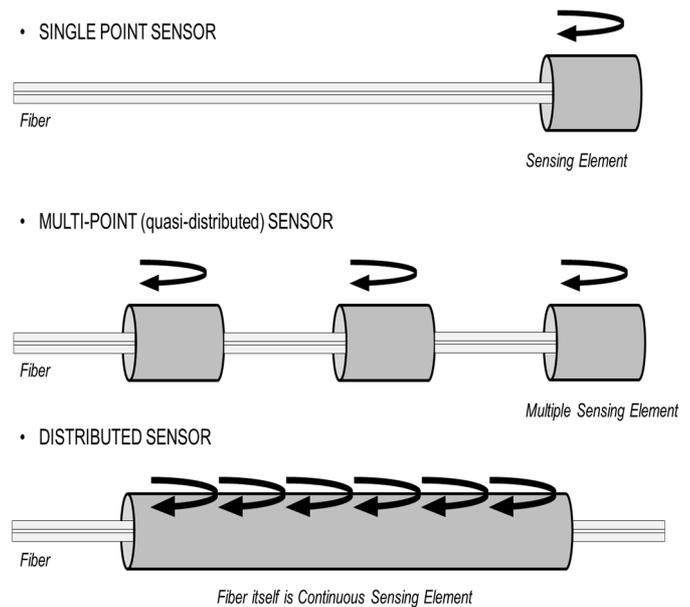
- Point sensor: detect measurand variation only in the vicinity of a single sensor. Example: micromirror at fiber tip. This is mostly used for chemical sensors, but also for EFPI.
- Multiplexed sensor: Multiple localized sensors are placed at intervals along the fiber length. i.e . FBG (sensor length 10 mm typical). About 10 sensors/fiber if multiplexed by wavelength, up to 1000 sensors by using OFDR (Optical Frequency Domain Reflectometry).
- Distributed sensor: Sensing is distributed along the length of the fiber, the optical fiber works simultaneously for transmitting the information and for sensing the local external variables (temperature, strain).

Figure 1 Topology of Fiber Optic Sensors

Fiber Optic sensors (FOS) offer a very low size, the optical fiber has a diameter of 150 microns, so it can be embedded within a ply into the composite material during manufacturing. Other benefits for FOS are EMI/RFI immunity, wide temperature range, very long cabling if needed, because of the low attenuation, and the multiplexing capability (several sensors on the same optical fiber). As sketched at figure 1, three topologies are possible:

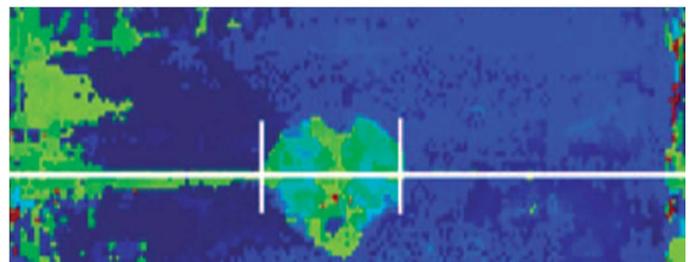
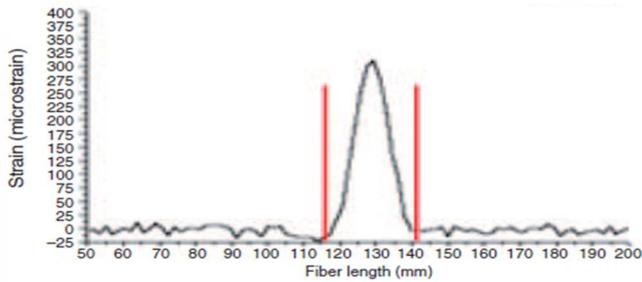
A sixteen plies crossply CFRP laminate was built from UD prepreg material by OOA (Out of Autoclave) procedures. A polyimide coated optical fiber was embedded inside the laminate during layup. The laminate was impacted by a drop weight test, and a delamination was produced. The white line show the position of the optical fibre, and the lower image (figure 3) show the strains measured by the optical fiber along this line. It can be seen the appearance of residual strains at the delaminated area. Worthy to mention strains caused by damage are significant, with a peak of 300 microstrains, and the delaminated length is perfectly depicted, 25 mm. In fact, the delaminated area can nearly be plotted if the optical fiber follows a crooked path, with parallel fibers every 5 mm. The strain field map of the area can be obtained with relatively high accuracy.

Figure 3.: Detection of the delamination caused by an impact; Ultrasonic C-Scan of the impacted laminate; (c) Strains measured along the white line of the upper figure by an O.F..

Two independent approaches have been described and experimentally validated. The first one is based on detecting the new strains appearing as consequence of a damage, it requires a sensor to be located just there; it is a very robust technique, and very simple to apply, but the area of damage detection is limited to the fiber path. It should not be misconsidered, it has similar qualities for damage detection as CVM, which currently is the only certified SHM technology for aircraft structures. The examples given demonstrate the high resolution of the technique; being able to detect delaminations as small as 5 mm (twice the resolution of the OFDR distributed interrogation systems).

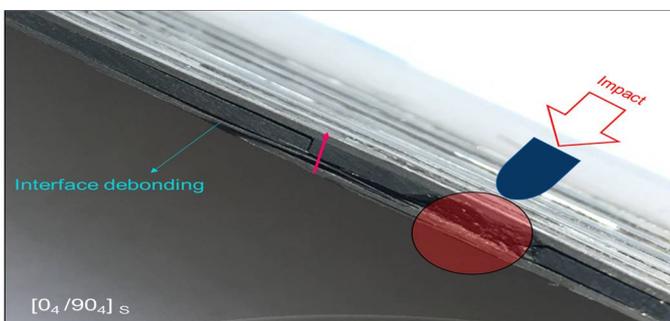
Figure 5. Delamination caused at a ($0_4, 90_4$)_s CFRP laminate after a 5 J on-edge impact

The laminates were submitted to impacts of controlled energy, by using a drop weight test machine, both perpendicular to the laminate and on-edge direction. The energy was gradually increased until a visible damage was produced (figure 5), and the residual strains were recorded after every impact (figure 6).

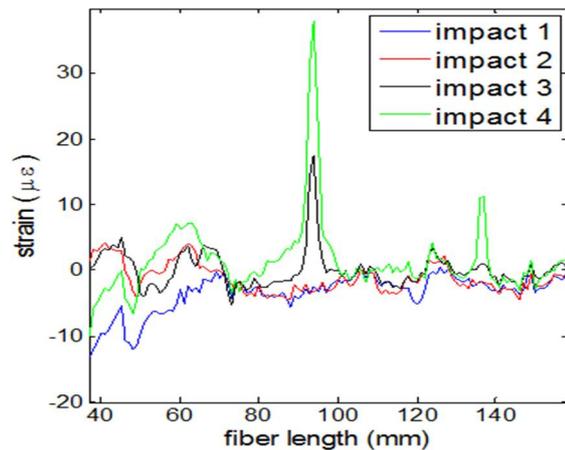
Figure 6. Strains recorded by the optical fiber after successive impacts of increasing energy, from 2 to 5 joules. The two identifiable peaks recorded at 100 and 140 mm are for the first and second loops of the optical fiber, respectively

Similar findings were obtained when impacts were done at the direction normal to the laminate. For these tests, an embedded O.F. was used, located at the second ply of the surface opposed to the impact. The energy needed to cause a BVID was slightly higher than in the former case. These results show the high reliability of the technique, as far damage happen on the optical fiber path, and a system is available to get the strains all along the fiber with adequate spatial resolution.

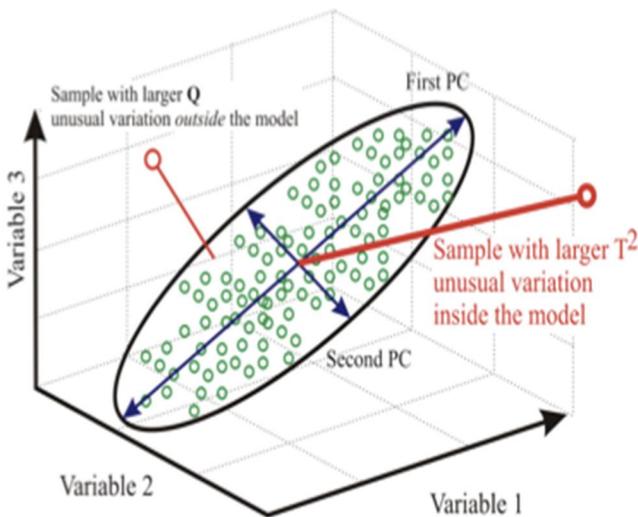
Fig 7. Schematics of the PCA algorithm. Firstly identify a new coordinate system which reduce the dimensionality of the data set. Secondly, identify if new data fits or not inside the former reference system.

1. Organize the data set as $n \times m$ matrix, where n is the number of tests (each load case or load increment is a new test) and m is the number of measured variables (sensors) . X
2. Normalize the data to have zero mean and unity variance

3. Calculate the eigenvectors-eigenvalues of the covariance matrix. $C = X X^T$
4. Keep only the first eigenvectors as the principal components. Baseline
5. Project any new collected data into the former Baseline
6. Identify if new data follow global trends (Damage Index)

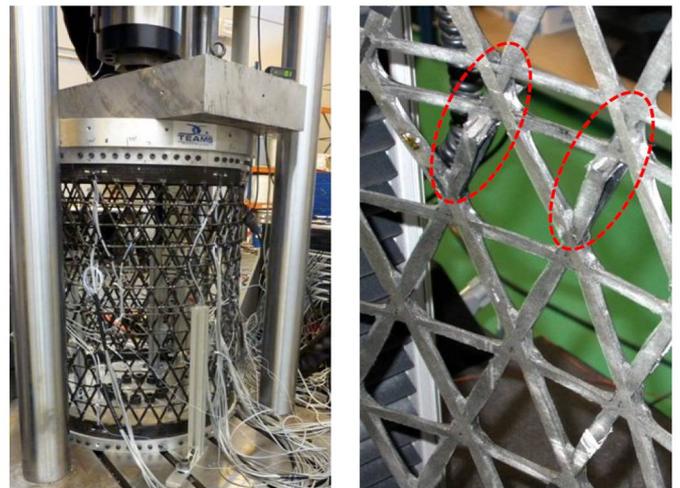
Figure 8. Isogrid structure under compression test. Detail of broken bars after exceeding the max. load

A large size structure, 1100 mm height and 800 mm diameter, has been manufactured by automatic tape laying process using high modulus graphite fiber and out of autoclave curable resin system. It was instrumented with 36 FBGs and tested to failure under compressive loads (figure 8). First failure happened at -330 kN, with some broken bars, but still the

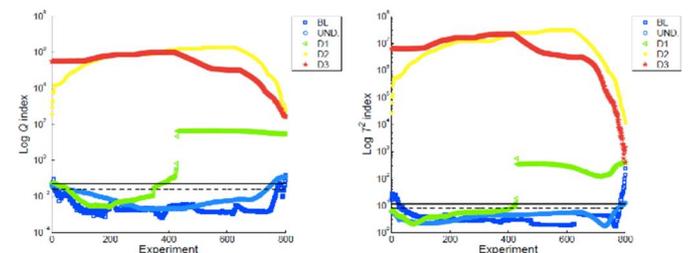
Figure 10. PCA algorithm applied to isogrid strain data. Blue lines are damage indexes calculated from strains acquired on the undamage structure, each experiment means a new data acquisition (load level); green line correspond to data taken under increasing loads, first failure happened at test 400.

structure retained its load carrying capability. Figure 10 show the strains acquired during the test, which gives evidence that slight manufacturing imperfections cause an uneven strain distribution, and a nonlinear response under load/unload conditions.

The application of the PCA algorithm to the former data set is straightforward, with quite good results (Figure 10). Worthy to mention that there is no need to prepare the data, neither a FEM model. It is only needed to arrange the X matrix (36 X 800), there were 36 sensors, and 800 measurements were taken to generate the baseline. Next measurements, projected on this baseline, easily discriminate the load which produce the first failure, and after that, next measurements have a clearly detectable damage index.

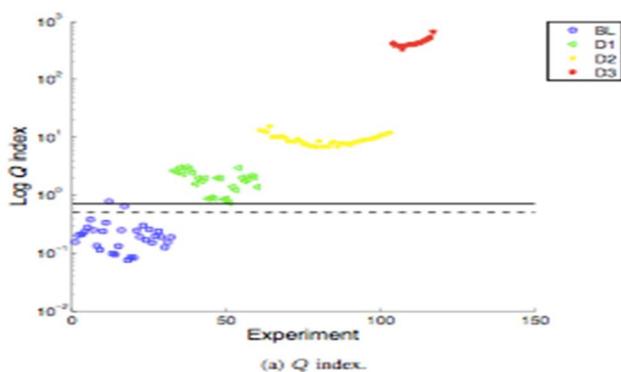
The damage index was calculated, and it was found that when debonding was 100 mm long, it was clearly detectable. Results are shown at figure 13, green dots. Obviously when new damages were inflicted at the main spar, as load carrying member, they were more easily detectable.

Figure 13. PCA algorithm applied to the Wind turbine blade

The second difficulty comes from the nature of the inflicted damage. To do a representative experiment, the typical damages that happen in WTB were reproduced, that is a partial debonding of the shells at the trailing edge. The blade 13,5 mt long, manufactured in the conventional way as a long spar with two bonded shells, was instrumented with 4 optical fibres, with 6 FBGs each, regularly spaced. For a cantilever beam under flexural loads, a partial trailing edge debonding changes the torsional stiffness, but do not alter strongly the bending stiffness.
